Emerald Ribbon Action Plan

Existing Conditions Report
DECEMBER 2023

PREPARED BY
Agency Landscape + Planning
Siglo Group

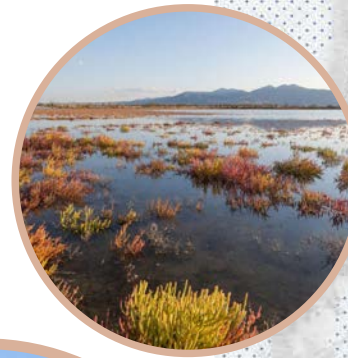
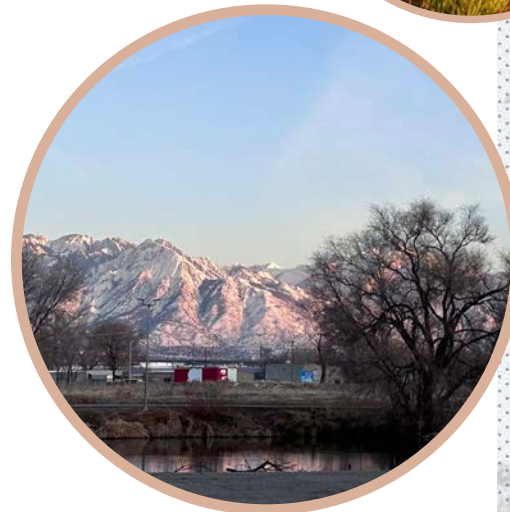
A river's ability to meander is key to a healthy ecological system. Artificial straightening allowed for increased urban development along the Jordan River.

HISTORICAL RIVER SECTION

River channel was historically wide and shallow with many surrounding wetlands and shrub habitat.

PRESENT DAY RIVER SECTION

Today, the river is much narrower with development on either sides, fewer wetlands, and more invasive vegetation and tree canopy.

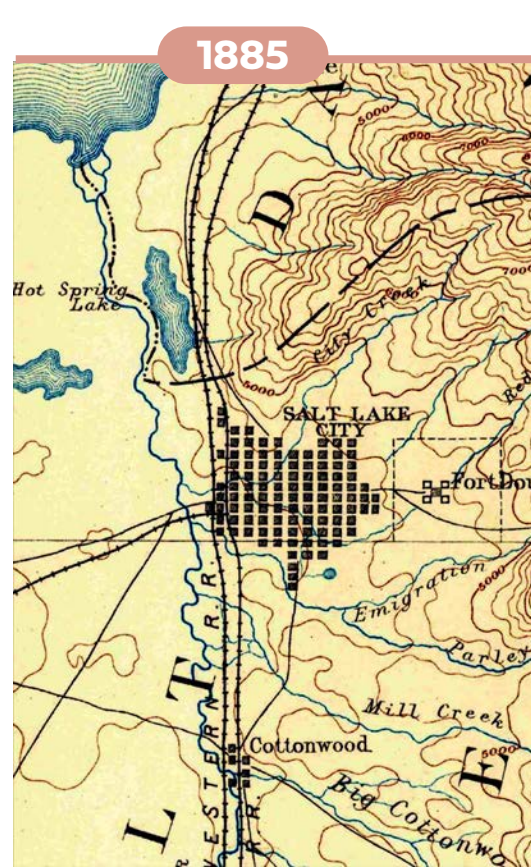
The river remains a meandering corridor, but some historical water bodies have already been filled in, such as Hot Spring Lake.

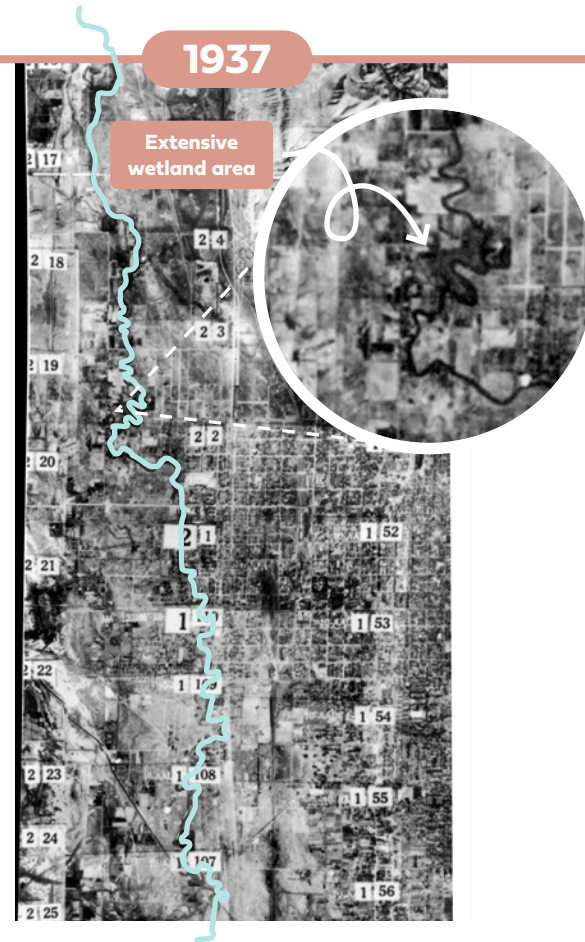
The dark coloration near the river indicates likely wetlands. The river is a meandering corridor through mostly rural lands at the western most edge of the built city.

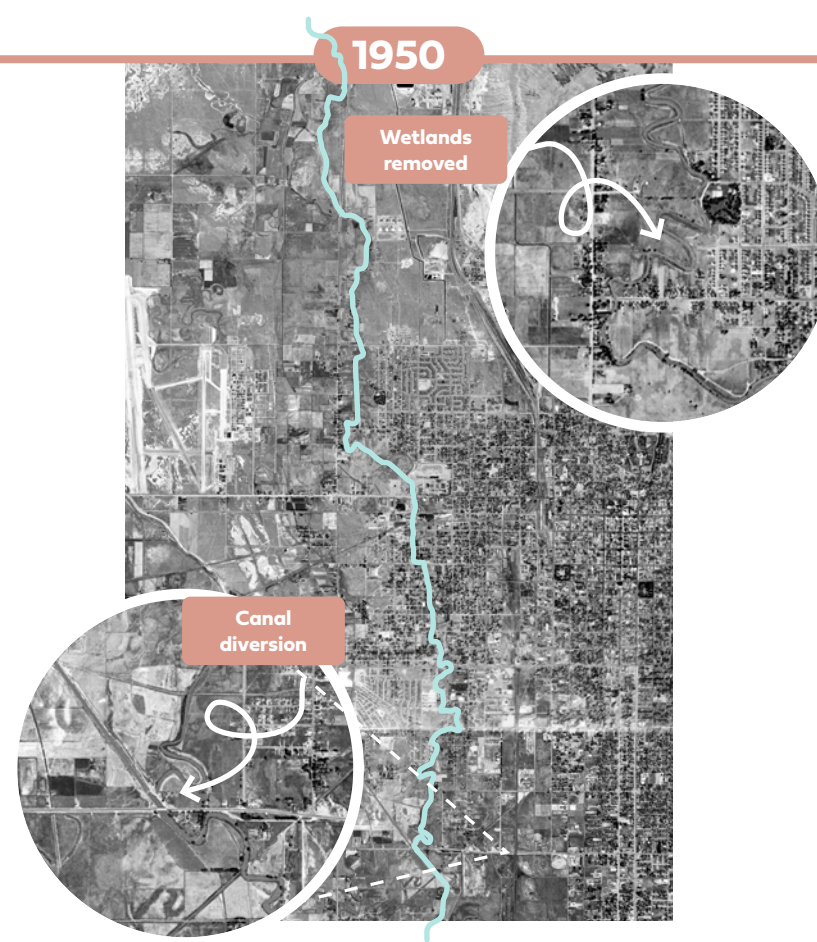
The downtown core of Salt Lake City has encroached westward beyond the river boundary. Much of the wetlands seen in 1937 have been filled in. The northern section of the site still shows a meandering corridor through undeveloped land.

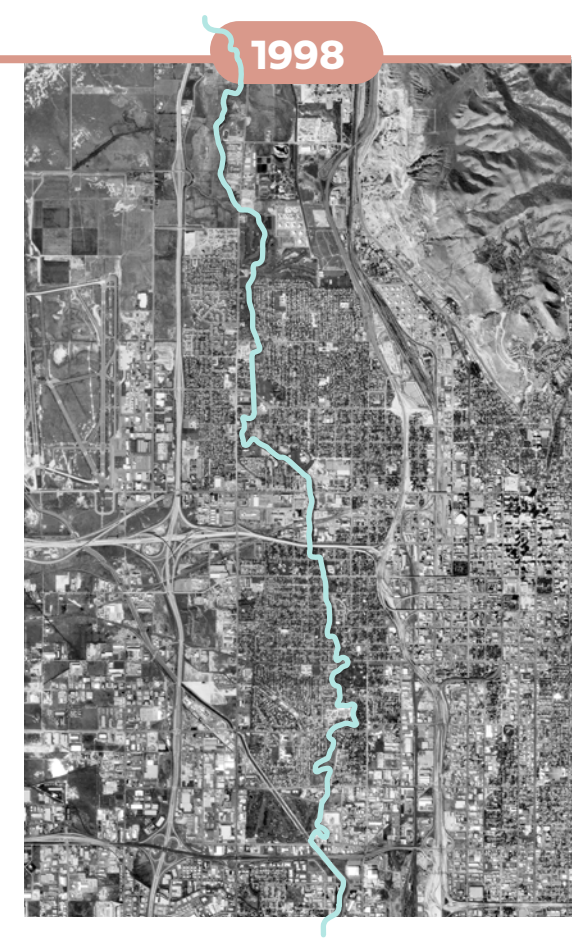
The river is heavily channelized. Its surroundings are highly developed and much of the open space within the study area is programmed for public use, such as golf.

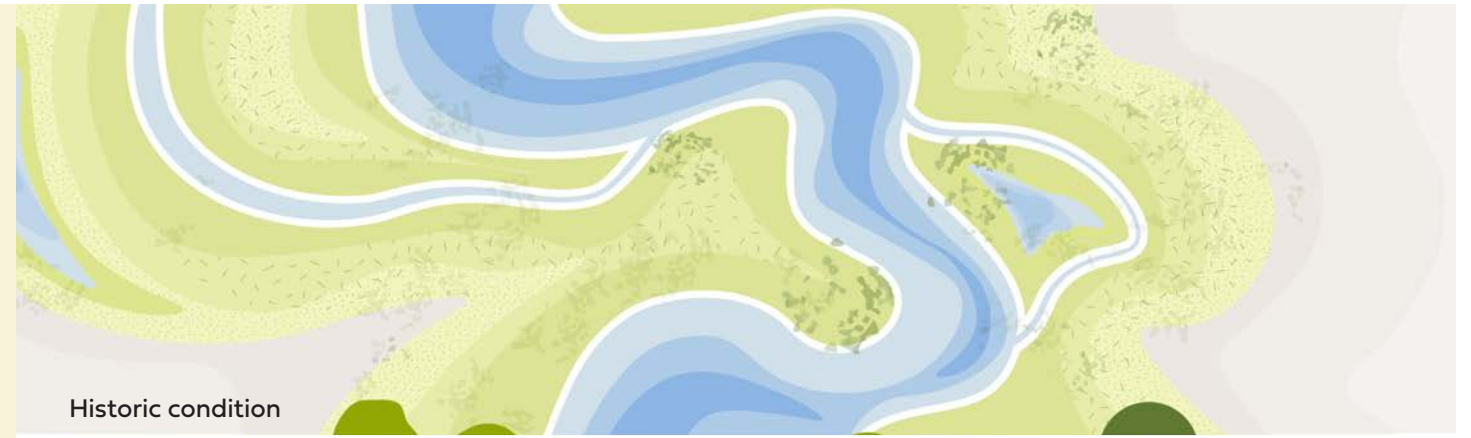
CHANGING COURSE

Wetland removal and corridor manipulation such as canal diversions and channelization have limited the river's water flow and capacity to mitigate contaminants or wash away debris.

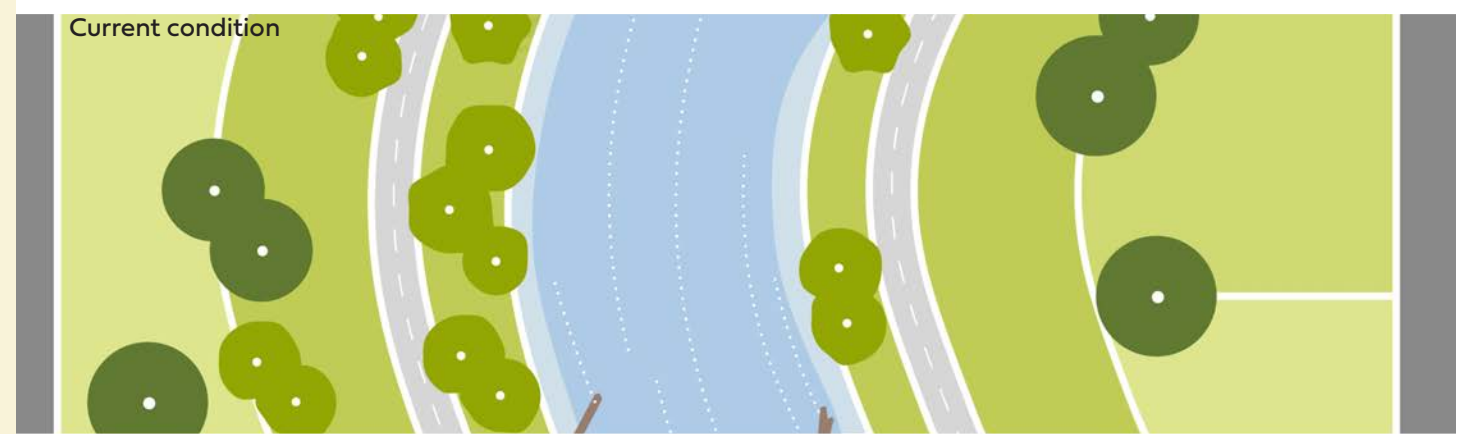
DOMINATED BY DEBRIS

Storm events wash urban and natural materials into the river.

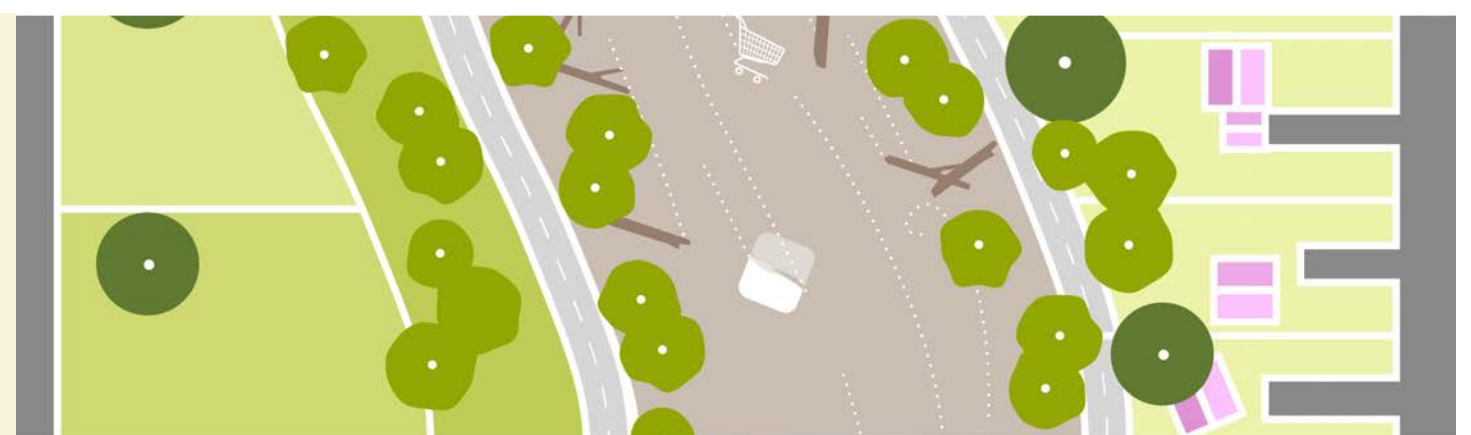
IMPACT OF INDUSTRY

Runoff from surrounding industrial and urban areas wash contaminants and unsafe bacteria into river.

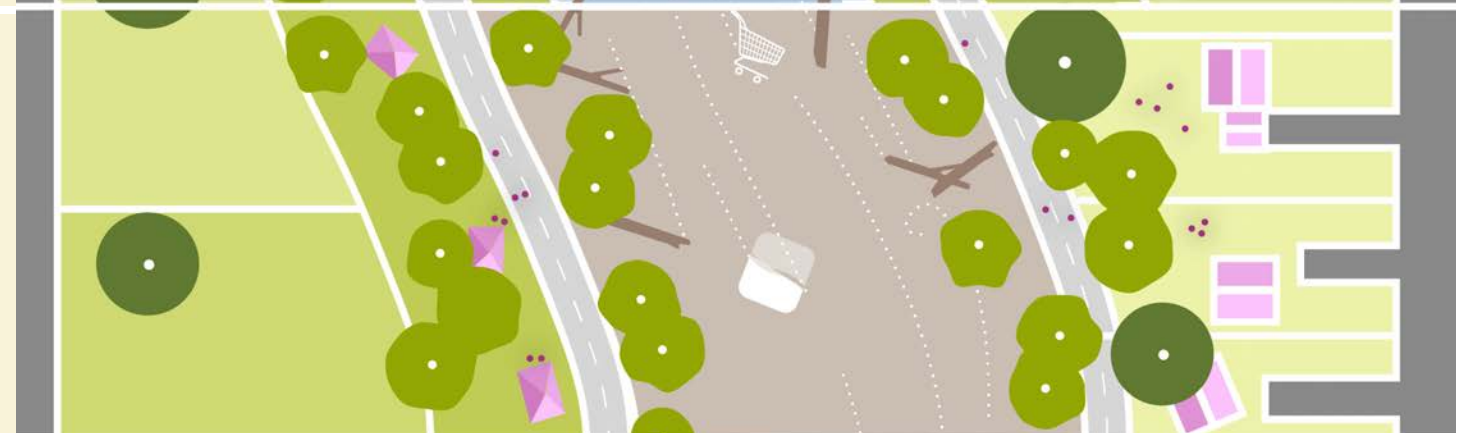
DOMINATED BY DEBRIS

Trash and debris along the river contribute to the perception that the river is not well maintained by the city.

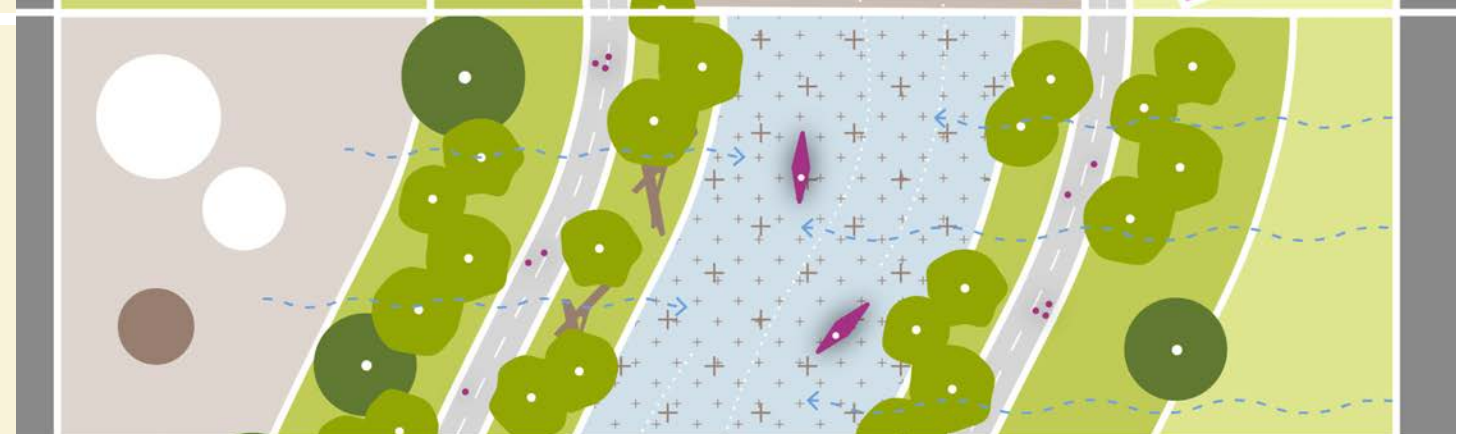
RECREATE AT YOUR OWN RISK

Paddlers have expressed that they exercise caution when coming in contact with the water due to contamination.
